Mitigation options for reducing beaver burrowing impacts on agricultural land in the River Isla Catchment, Scotland

For

NatureScot

June 2022

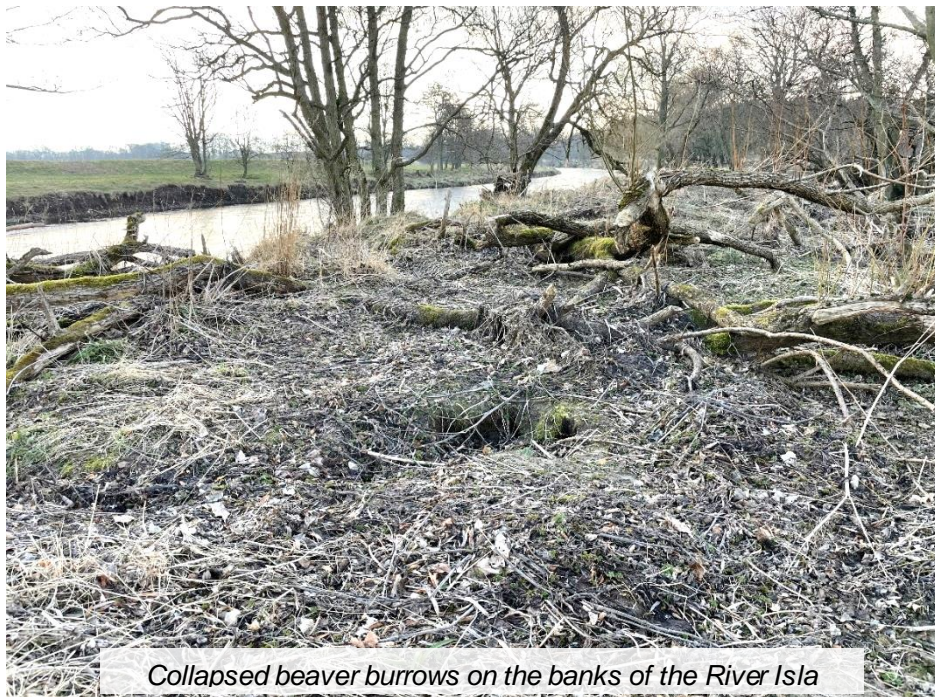
Collapsed beaver burrows on the banks of the River Isla

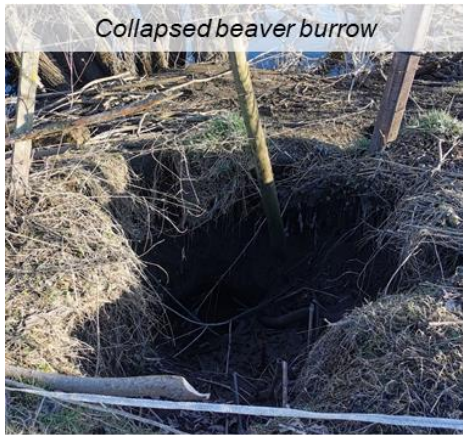
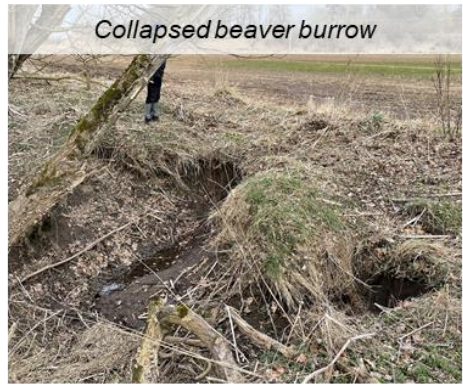
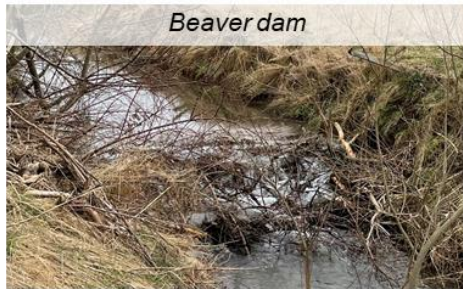
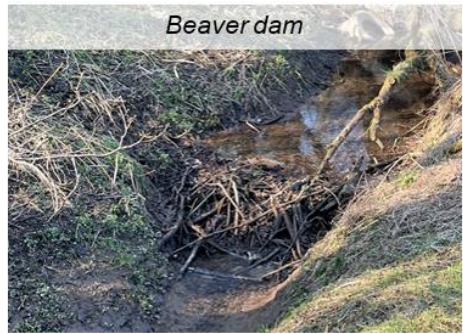
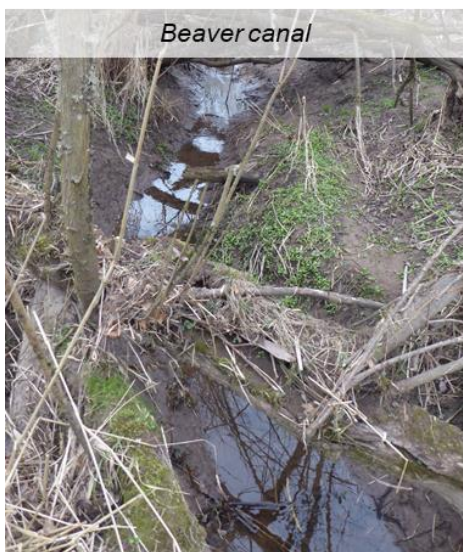
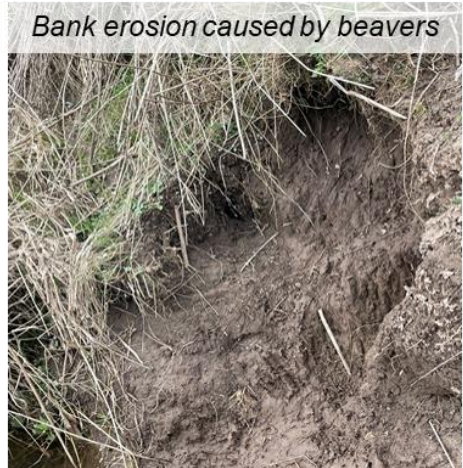
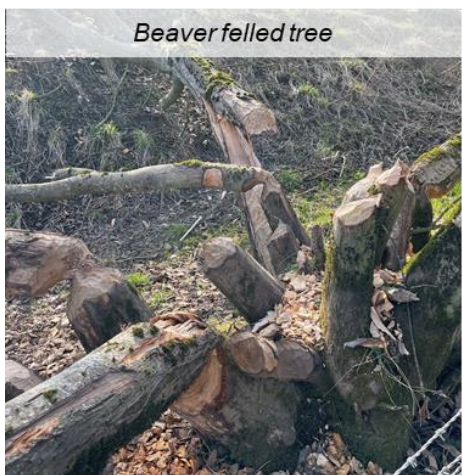
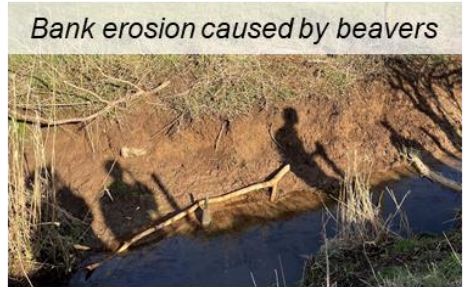
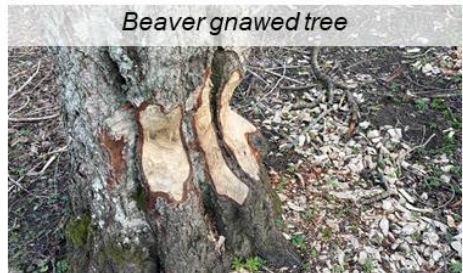
- Collapse / failure of embankments due to beaver burrowing – valuable land flooded, crop income lost, costs and time associated with clear up and repair
- Loss of land and fences due to riverbank erosion/collapse exacerbated by beaver burrowing / tracks / canals
- Blocking of channels with beaver dams – causing flooding of valuable farmland, bank slumping and continuous removal costs/time
- Public liability – beaver burrows often not visible and concern for liability if walkers/anglers were to injure themselves.
- Felled trees (by beavers) that have fallen into the channel are a downstream flood risk liability
- Mid-channel island erosion due to tree loss from beaver activity
- Elevated fine sediment deposition in ditches due to tree removal by beavers and bank erosion

Figure 4. Examples of beaver impacts in the lower River Isla catchment observed during the visits in March 2022.

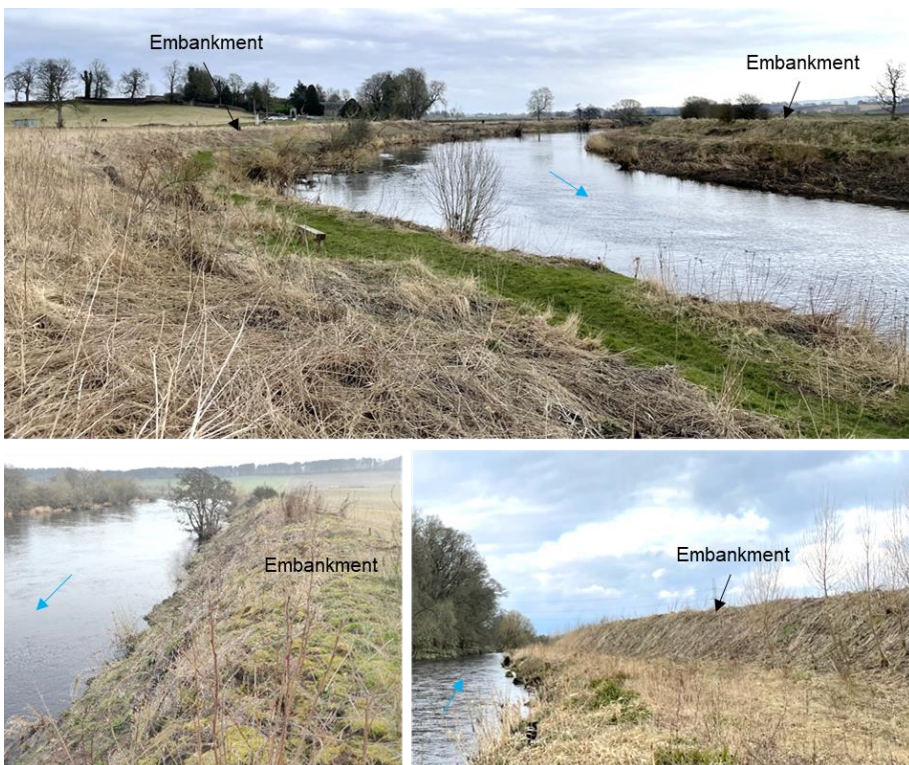
Flood embankments in the River Isla catchment, were mostly observed on the bank top or set back a short distance (2-10m) from the water edge (Figure 6) and therefore there is little room for natural river processes and flood water energy dissipation. Embankments were often vegetated with grasses and regularly managed (cut and repaired) by landowners/managers. The embankments would have originally been constructed using dredged river sediments or other floodplain material. In the River Isla catchment, most embankment material would therefore comprise of mainly fine loamy silts and sands with little cohesivity or inherent strength and therefore are easily eroded. Embankment heights varied from just above field level (often tying into high ground), to up to 3.5 m high. Landowners have expressed concerns relating to the reduced stability of embankments in the River Isla catchment due to beaver burrowing activity.

Figure 6. Photos showing embankments on the River Isla taken in March 2022, blue arrows indicate flow direction. Embankments are commonly set back a short 2-10m distance from the water edge (top photo and bottom right photo) or located directly on the bank top (bottom left photo).

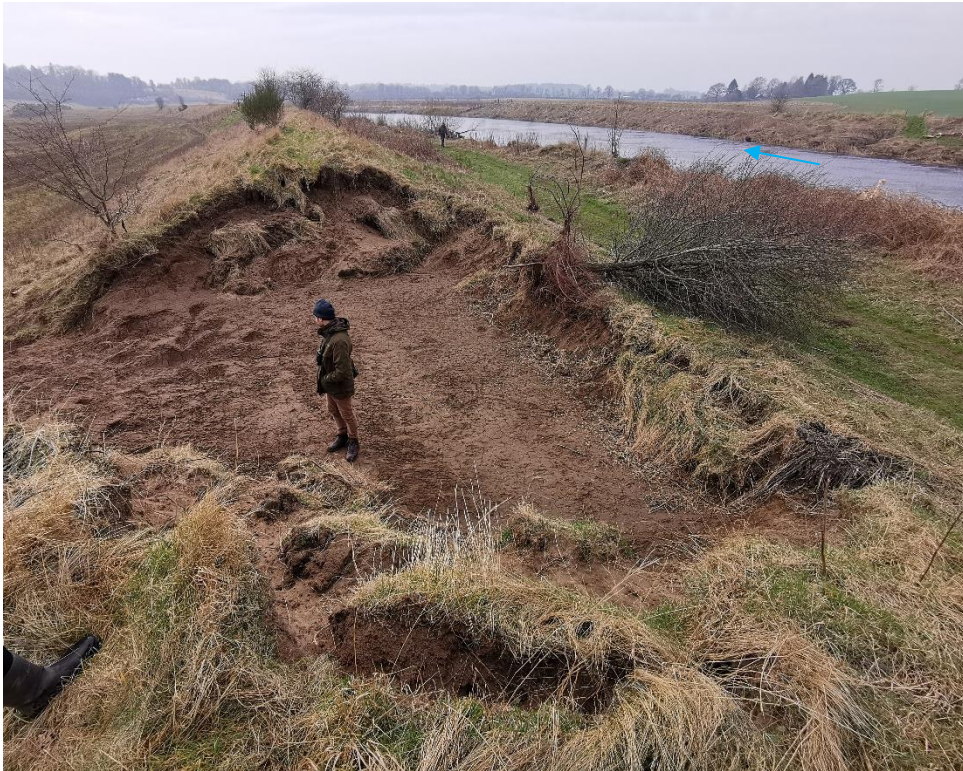
Figure 7. Example of embankment ‘blow out’ on the River Isla, this could have been caused by a combination of factors – embankment crest-overtopping by flood flows leading to scour on the landward side of the embankment and the weak bank materials used to construct the embankment. Beaver burrowing is less likely to have contributed to this embankment blow out due to the position of the embankment being set back from the river channel (>20m) and the shape of the scour hole on the embankment on the landward side.

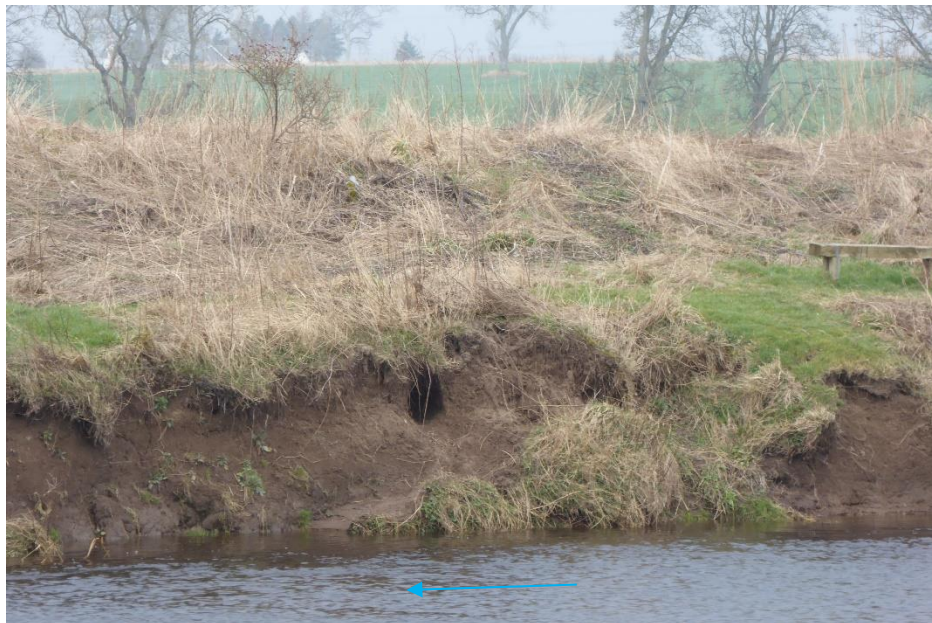
Figure 8. Animal burrowing on eroding bank. This can contribute to localised bank erosion during flood events when water flows into the open burrow saturating and collapsing the roof, causing the bank surface to slump.

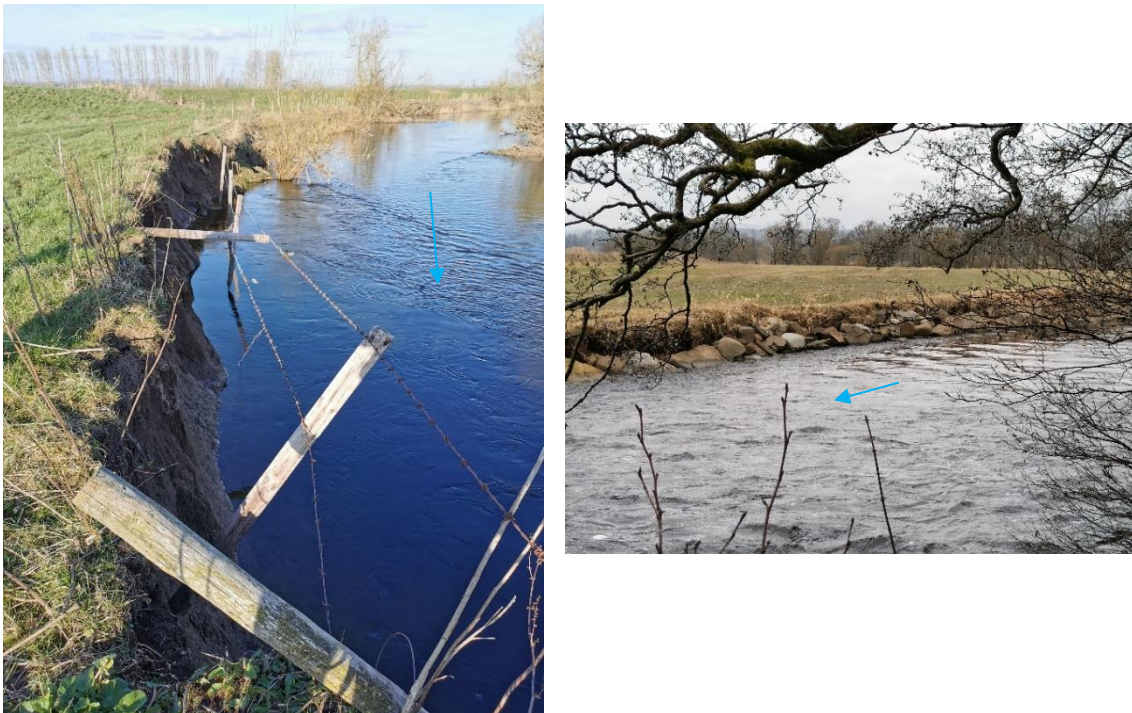
Landowners expressed concerns over bank erosion and loss of fences. These locations were often on the outside of meander bends (where velocities are highest, and erosion is the dominant process) or in straightened reaches (where energy is increased due to straightening and/or deepening/dredging).

Figure 10. Left - river bank erosion on outside of a meander bend, fence line is on the top of the bank and has been undermined. Right – example of bank toe reinforcement using large boulders ‘rip-rap’, this does not stop erosion but leads to excess bank erosion downstream where banks are not protected.

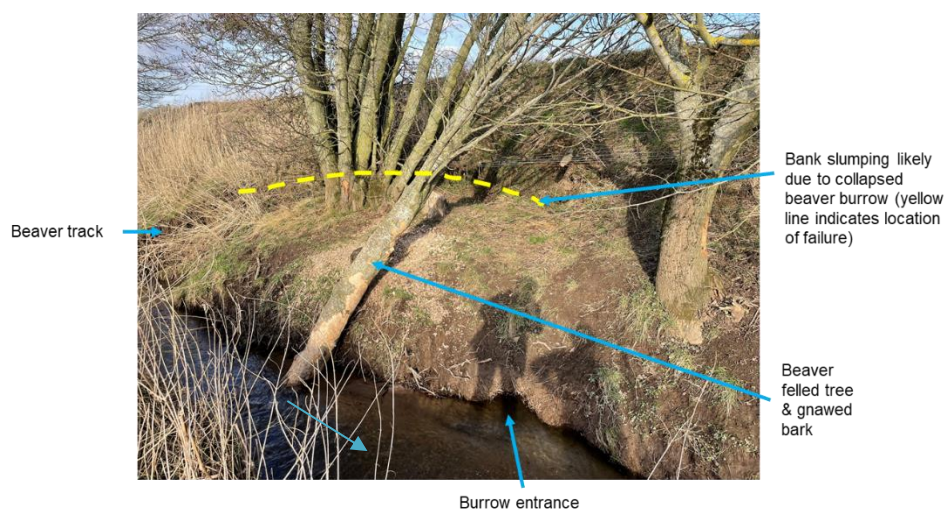
Bank materials in the River Isla catchment were composed of fine loamy sand and silts which lacked cohesivity, there was also a lack of mature bankside vegetation. Tree roots can physically bind sediment particles together, roots and vegetation can act to armour and protect the bank face sediments from fluvial entrainment, as well as increasing soil shear strength. In some situations, mature riparian vegetation was removed by landowners due to concerns over liability related to trees falling into the channel and contributing to flood risk or damage to properties downstream. In other locations, the riverbanks were often kept 'tidy' and over-managed through regular cutting and management and therefore only had one or two vegetation species (predominantly grasses which have a shallow root structure). On some sites visited, despite no livestock grazing pressure there was very limited riparian tree cover which could have arisen from other pressures such as vehicle (car, tractor etc) access, recreational access by fishing users, public access including horses and embankment repairs and reprofiling. Beaver burrow collapses were often observed where there were no, or isolated scattered trees, where there was little riparian bankside vegetation cover.

Figure 11. Example of the impact of beaver activity on bank erosion / stability in the River Isla catchment.

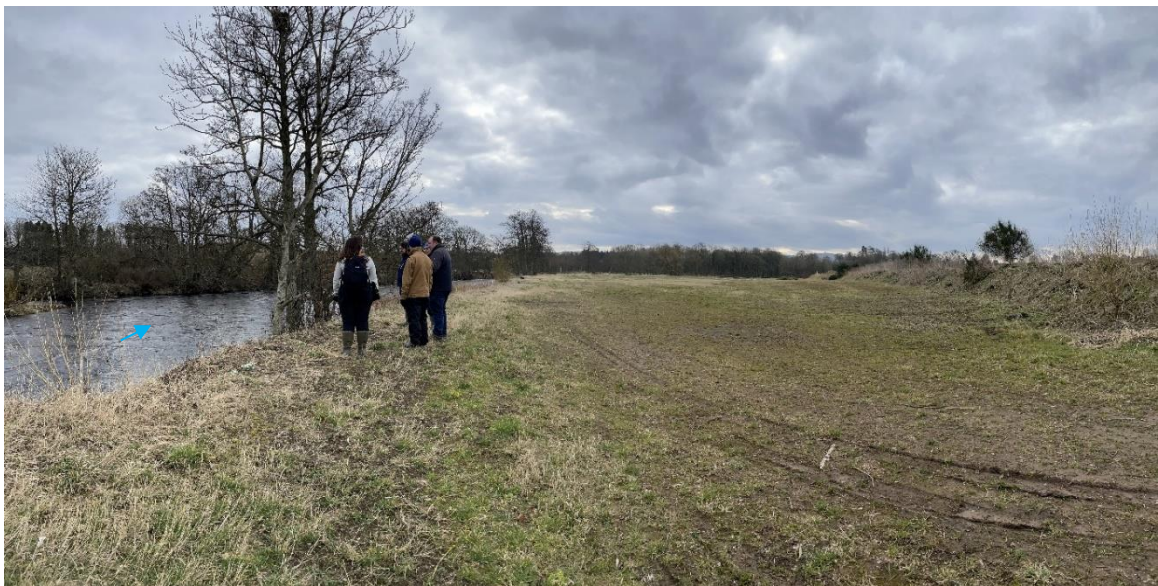
Figure 12. Example where the flood embankment is set back up to 60m from the riverbank allowing space for natural river processes and flood conveyance and avoiding any beaver burrowing activity due to the distance from the river bank. The grassed area could be improved by encouraging mixed vegetation growth.

In Bavaria, 90% of beaver conflicts with society occurred within 10 m of the water's edge (Campbell-Palmer et al., 2016). Where flood embankments are set back from the main channel by a distance greater than 30m the impacts of burrowing are insignificant (Campbell-Palmer et al., 2016). Conflicts further away from this have been observed, however, this is often rare and usually associated with an attractive food source (Campbell-Palmer et al., 2016). Creating space for natural processes and beavers could involve removing or setting back embankments (at least 20-30m from the channel. e.g. Figure 12), if setting back embankments various aspects of design and construction should be considered:
