Mitigation options for reducing beaver burrowing impacts on agricultural land in the River Isla Catchment, Scotland

For

NatureScot

June 2022

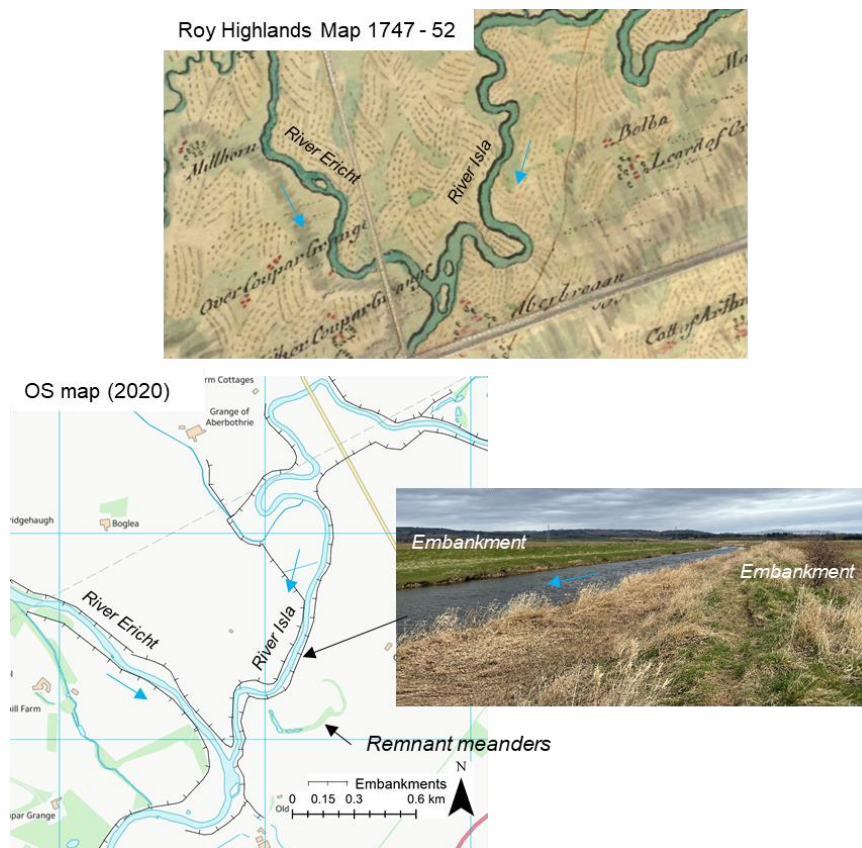
Parts of the River Isla have been historically straightened evidenced in the historic maps (e.g., Roy Highlands Map (1747-52) and the OS maps (1850s – 1990s)) and topographic data (e.g., depressions of remnant channels visible in high resolution LIDAR data), from a previously meandering channel with mid-channel bars (Figure 5). This is likely to have occurred pre- or during very early embankment construction and has resulted in uniform river reaches (e.g., uniform in shape where all diversity in forms that provide habitats have been removed), with old paleo channels isolated from the main river (Figure 5). Straightening a meandering channel increases the bed slope (because of a reduction in channel length), and therefore water moves more quickly downstream. This results in an increase in river energy and therefore more potential for bed and bank erosion, which can lead to bank instability. The 2019 SEPA hydromorphological report highlighted that the River Isla catchment has shifted from a predominantly depositional catchment to an erosional catchment.

Figure 5. Historic map (Roy Highlands Map 1747) compared to present OS map (OS data © Crown Copyright and database right 2020) showing straightened sections of the River Isla and River Ericht with setback embankments, remanent meander bends were observed in the floodplain.

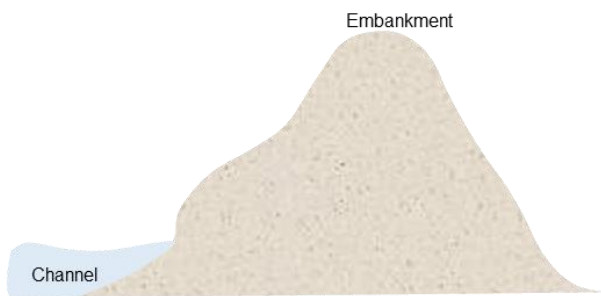
1. Cross sectional view of channel and embankment

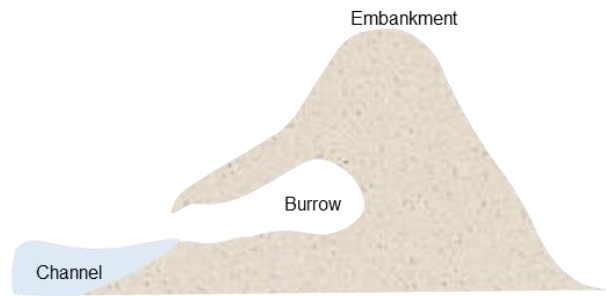
2. Beavers burrow into the side of the bank/embankment near the waters edge.

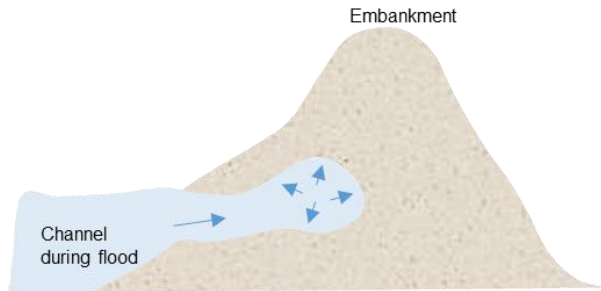
3. During floods, as water levels rise the beaver burrow can be flooded, the high water pressures can lead to erosion of the beaver burrow

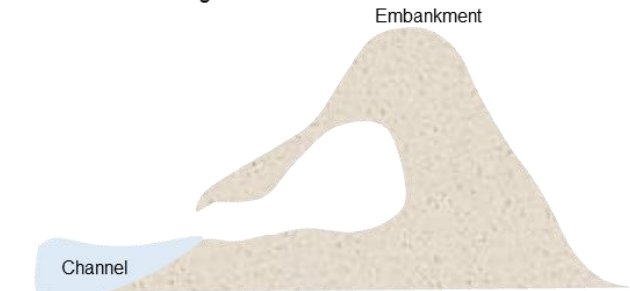
4. The beaver burrow is enlarged, weakening the embankment leaving overhanging bank material.

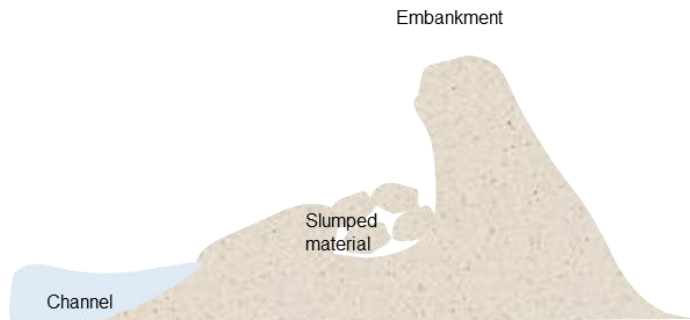
5. The overhanging bank material is eroded during subsequent flood events, or slumps due to over burden weight leading to collapse of the embankment. Slumped material is either transported downstream or deposited at the bank toe.

Figure 9. Conceptual diagram showing how burrowing into banks can lead to bank weakening (note burrowing into bank/embankments is one factor influencing stability, and there are often multiple interacting factors leading to bank/embankment collapse).
